**LEVEL 2 REPLACEMENT RESERVE REPORT FY 2024
MIDDLESEX BEACH ASSOCIATION**

MIDDLESEX BEACH ASSOCIATION

BETHANY BEACH, DELAWARE
 January 15, 2024
 Revised April 08, 2024

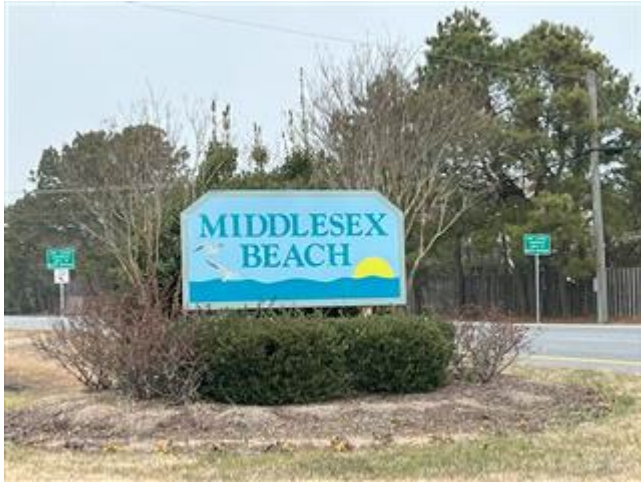
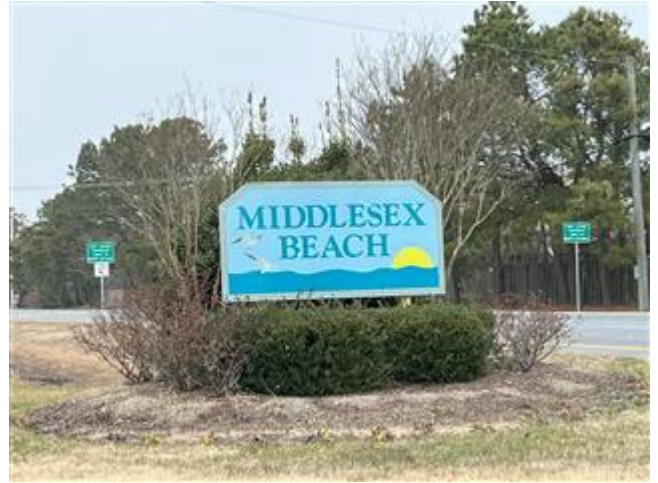
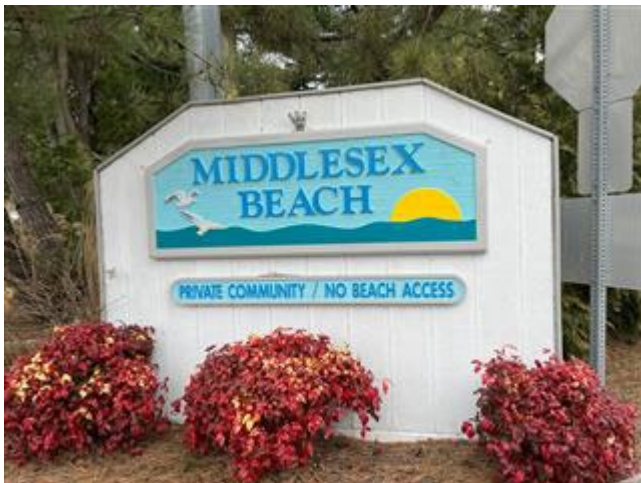
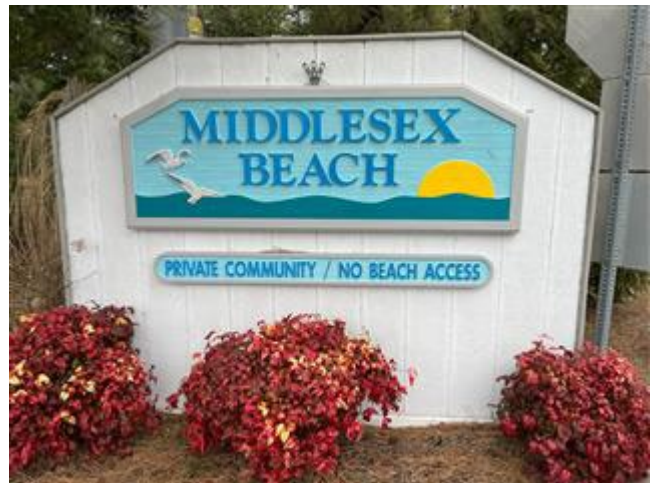
We recommend replacement every 10 to 15 years to keep the signs fresh and appealing.

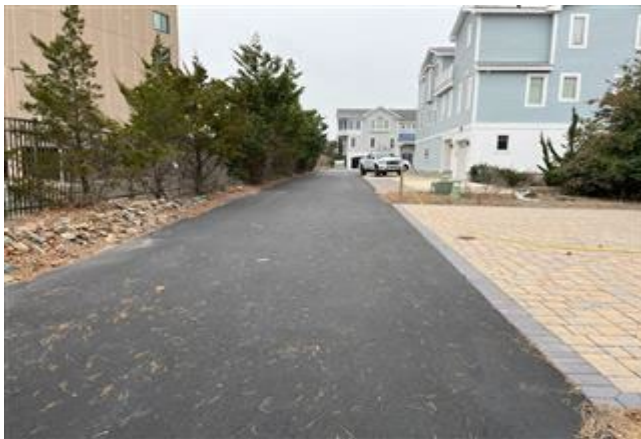
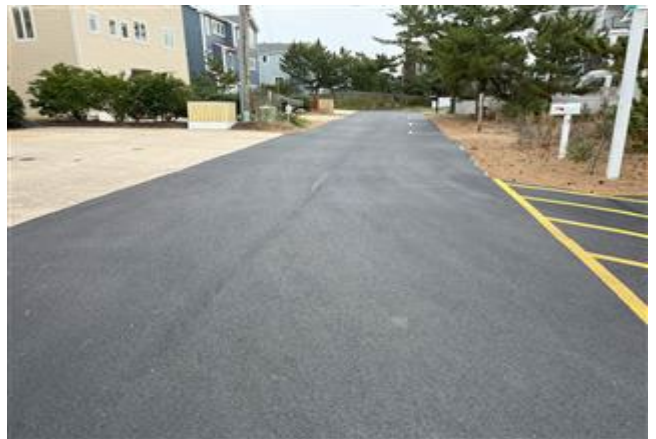
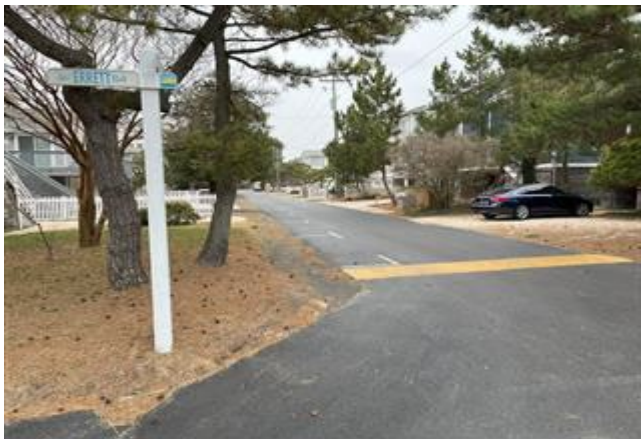
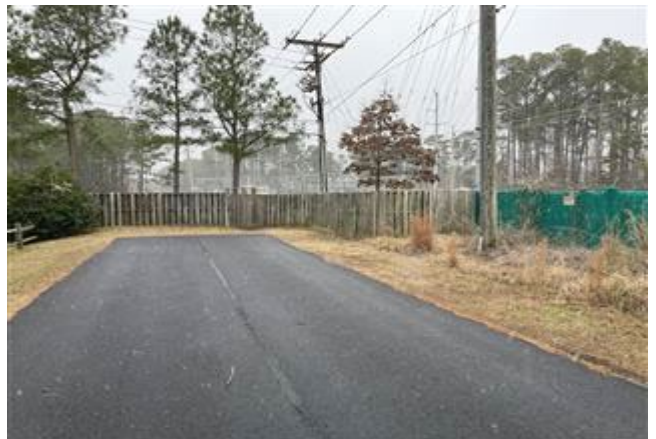
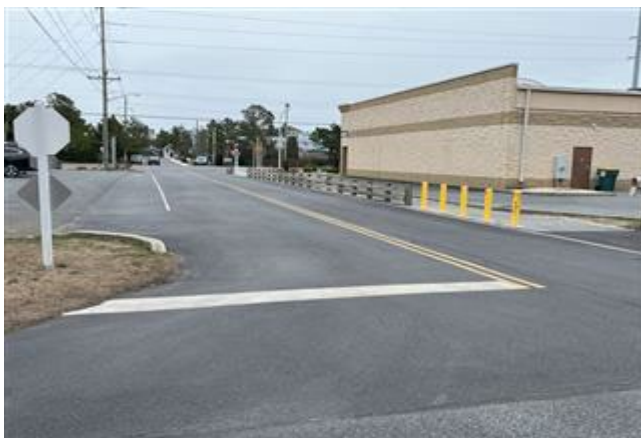
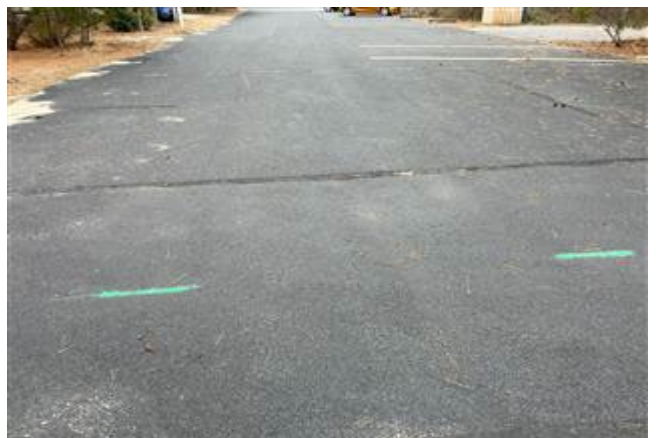
Asphalt Pavement. The Association is responsible for the roadways and parking areas within the community including the Commercial sections between Coastal Highway and Beach Plum Rd. The Town of South Bethany maintains the Pine Side and Commercial sections of Evergreen Rd. (the east side of Evergreen Rd., however, is Association property). In general, the Association's asphalt pavements appear to be in good condition (despite their apparent ages), with some alligatoring present at the west ends of the community roads, and deterioration at the cul-de-sac of Evergreen Rd. (east). The age(s) of the asphalt components is unclear, but the overall good condition suggests quality installations. In addition, light vehicle traffic and virtually no through traffic (with the exception of the Commercial sections), have contributed to the overall longevity. For the purposes of this Reserve Study, we have divided the asphalt mill and overlay of the community roads and parking areas into three phases to reflect their varying conditions. In addition, we have modeled for seal coating in three general phases. We have also modeled for full-depth repair to the section of Evergreen Rd. (beach side) that is deteriorated.

The defects noted include the following:

- **Minor Heaving.** This is damage to pavement surfaces caused by tree roots. Repairing these areas requires removing the asphalt and the tree roots, then replenishing and re-compacting the base material and resurfacing the asphalt. Root trimming can also be an effective way to control this defect.

- **Edge Cracking.** Asphalt pavement sections have developed cracks along the pavement edges due to improper confinement. Installation of curbs or installation of a compacted gravel shoulder at the time of an overlay project can address this defect.

As a rule of thumb, asphalt should be overlaid when approximately 5% of the surface area is cracked or otherwise deteriorated. The normal service life of asphalt pavement is typically 18 to 20 years.

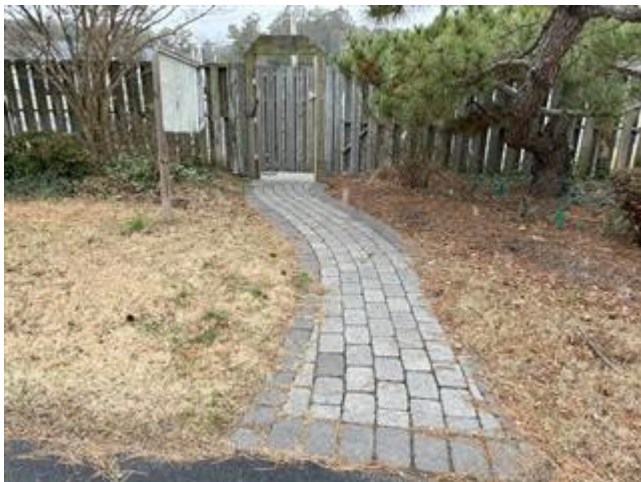
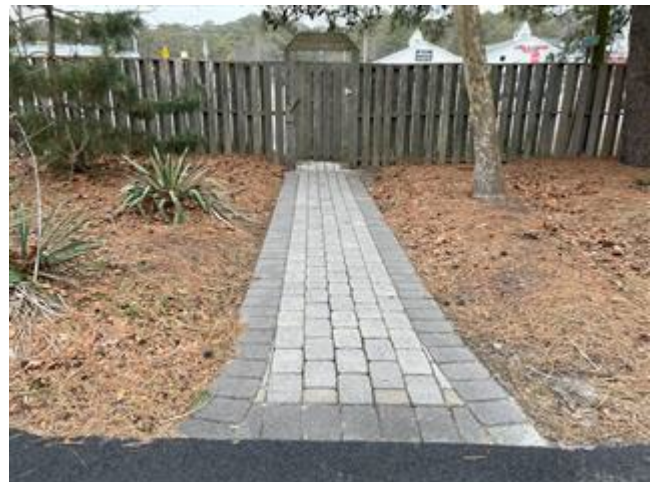
Unit Pavers. Unit pavers provide a solid, decorative, and renewable surface that is part of the community between the Coastal Highway at the gates to the east side roads, as well as, at the beach access paths and guard house. The unit pavers appear to be in overall good condition, though ongoing maintenance is required to remove eroding sand, which also limited our view of the pavers. The pavers at the Evergreen Rd beach access area are due for resetting. We have modeled for resetting of 33% of the pavers every 5 years and for replacement of the pavers every 40 years. The areas of defects are consistent with the age of the installation. BE AWARE THAT THE BEACH ACCESS PATHS AND DUNE CROSSING COMPONENTS (OTHER THAN PAVERS), WHICH INCLUDE DUNE FENCING, MOBI-MATS, AND WOODEN PATH BORDERS, ARE NOT IN THE COMPONENT LIST OF THIS RESERVE STUDY. IT IS UNDERSTOOD THAT THESE ARE MAINTAINED WITH OTHER FUNDS.

The defects noted include the following:

To correct defects and provide the longest service life of the unit paver system, periodic re-setting is required. Re-setting provides an opportunity to replace broken unit pavers, fill in voids in the foundation material, and level the surface areas. We have included an allowance for periodic re-setting of those portions of the system.

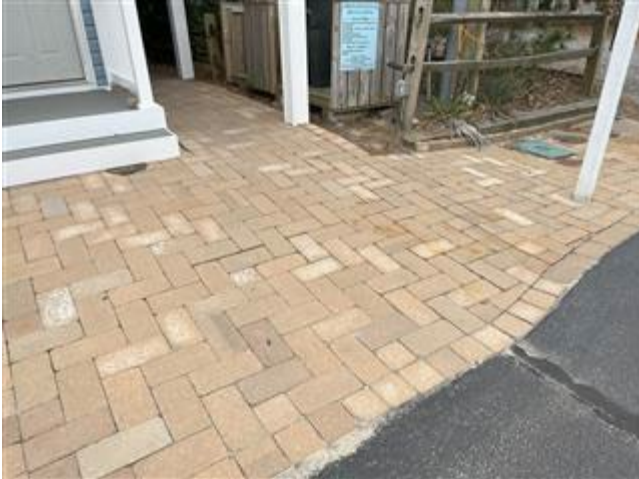
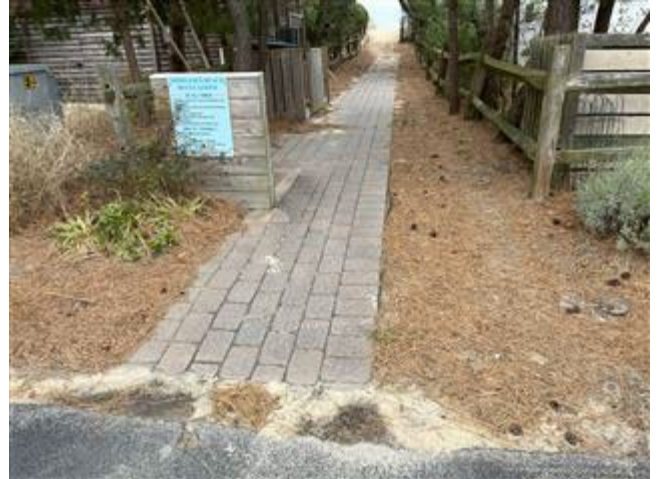
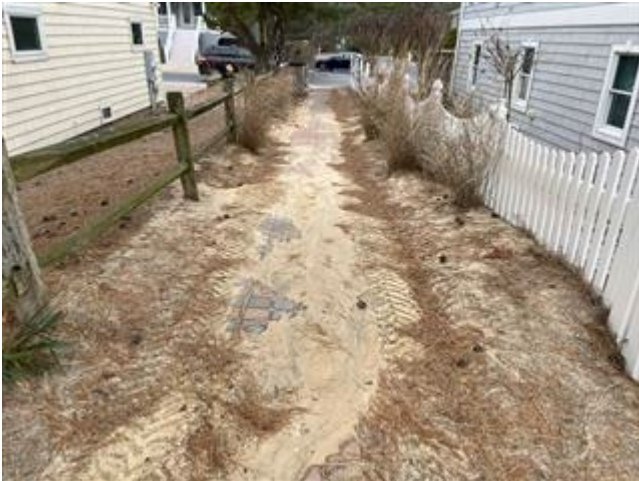
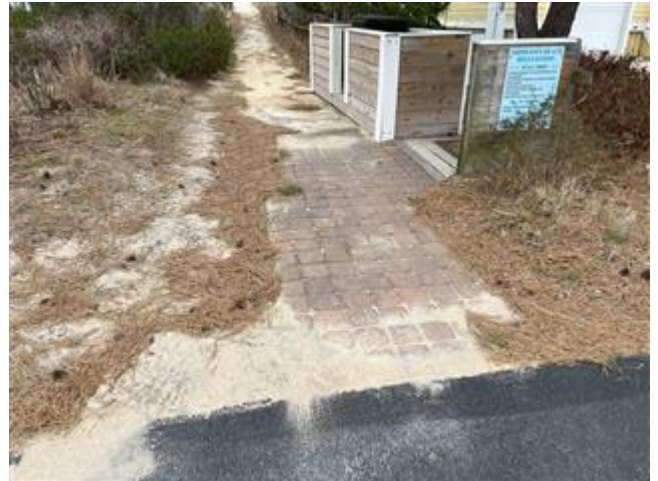
- Settlement. We identified areas where pavers have settled due to a failure of the base under the pavers. This settlement has resulted in an uneven surface that can pose a trip hazard.
- Stressed perimeter border. We observed areas of the perimeter border that have failed leading to the separation of the unit pavers. This defect is hazardous and can cause additional defects to develop.
- Unit paver system installed on a slope. Unit pavers installed on a dramatic slope, or elevation change will gradually slide toward the bottom creating a hazardous situation. Areas with a dramatic elevation change should be redesigned to include additional tiers.

Unit pavers have a service life of 30 years or more if the system is maintained on a consistent periodic basis. Eventually, the system will require a large-scale replacement, identical paver units may not be available, and it is recommended that the unit paver system be replaced.

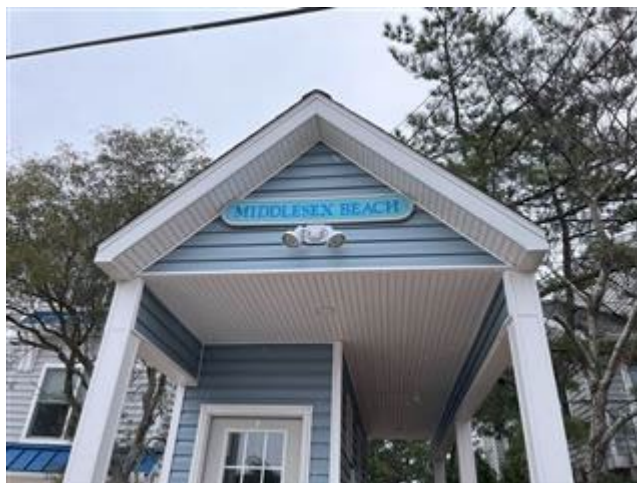
Guard House Monitoring. The Association is in the process of installing two security cameras and a DVR at the guard house.

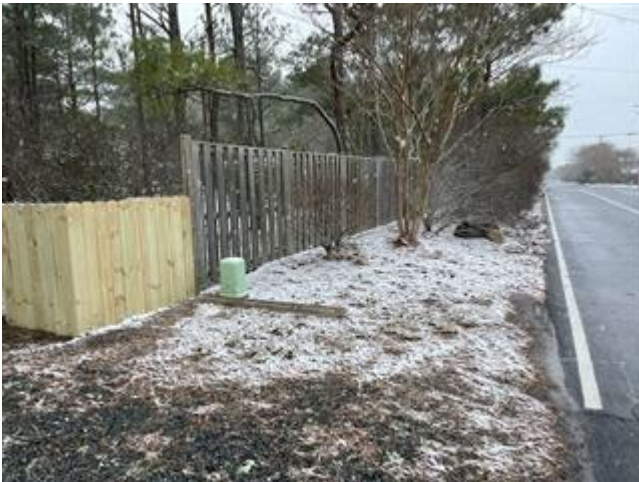
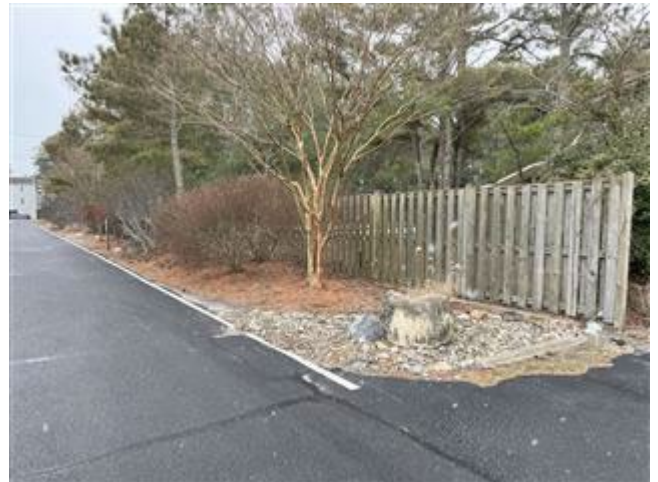
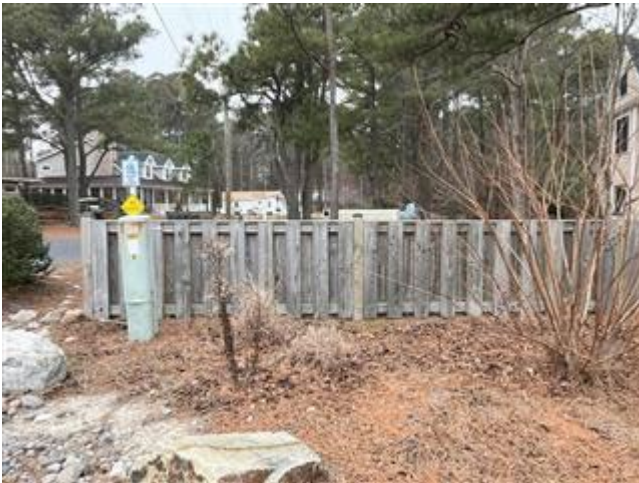
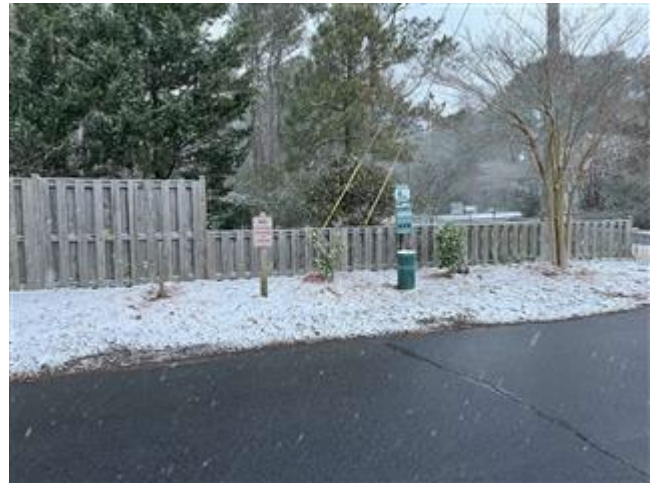
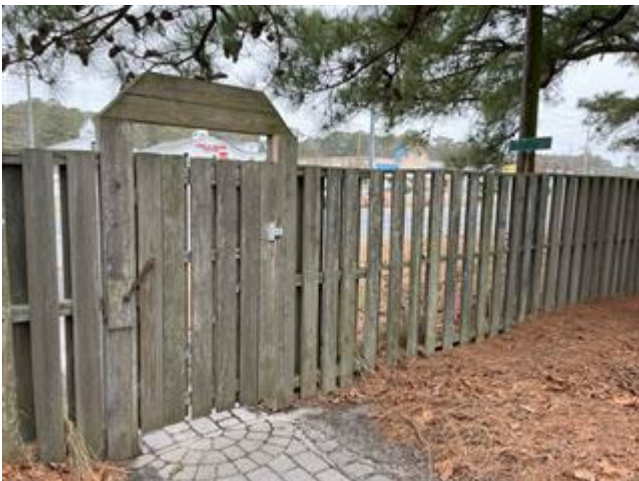
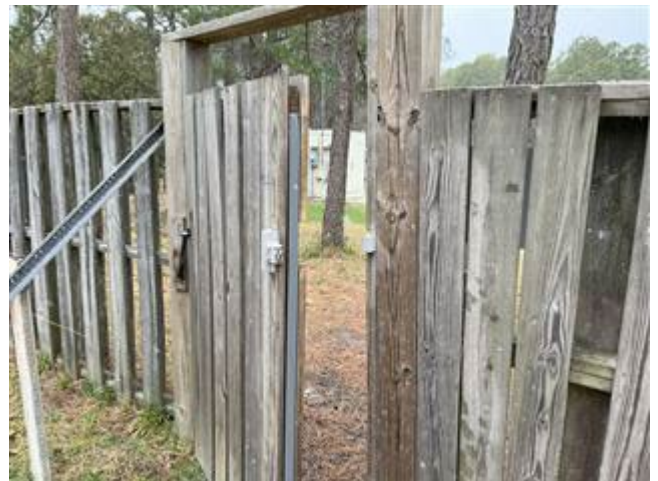
Shadowbox Fencing:

Fencing. The Association maintains various fences in various locations. The fencing includes primarily 6' shadow fencing, but there are also areas with stockade fencing, solid fencing, and short sections of 3' stockade fencing. The fences are in various conditions from poor to good. Around 775 ft of shadowbox fencing is scheduled for replacement (675 ft at the east side of Ocean Highway, and 100 ft at the west end of Bridge Rd.). Other fencing will be modeled into the Reserve Study according to expected remaining life and condition. Fencing systems have a large number of configurations and finishes that can usually be repaired as a maintenance activity by replacing individual components as they become damaged or weathered.

Pressure-treated wood fencing should be cleaned and sealed every year or two. Typically the least-cost fencing option, this type of fence can last 15 to 20 years if maintained properly.

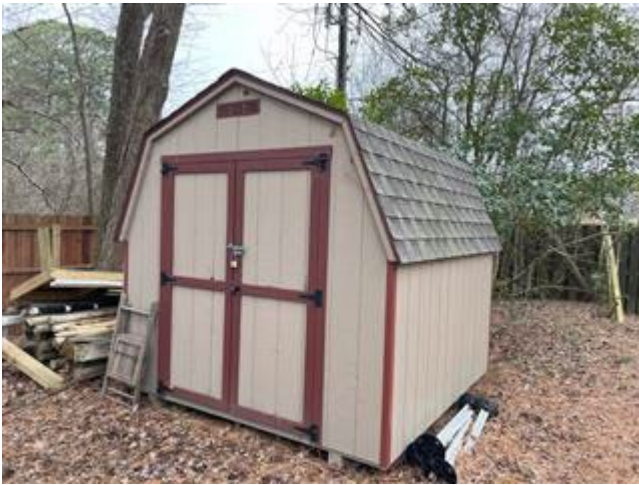
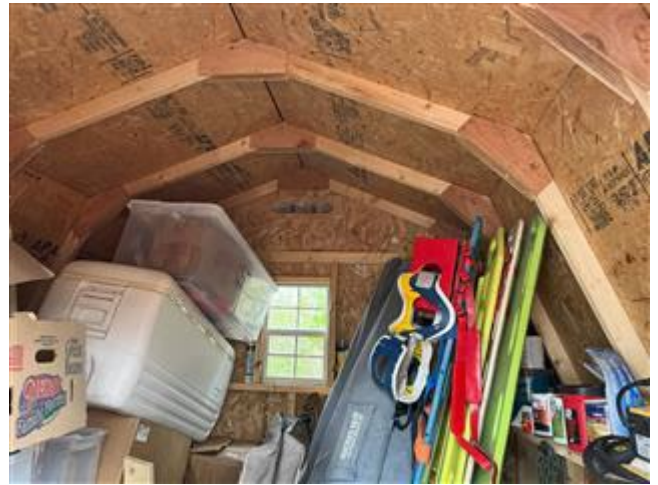
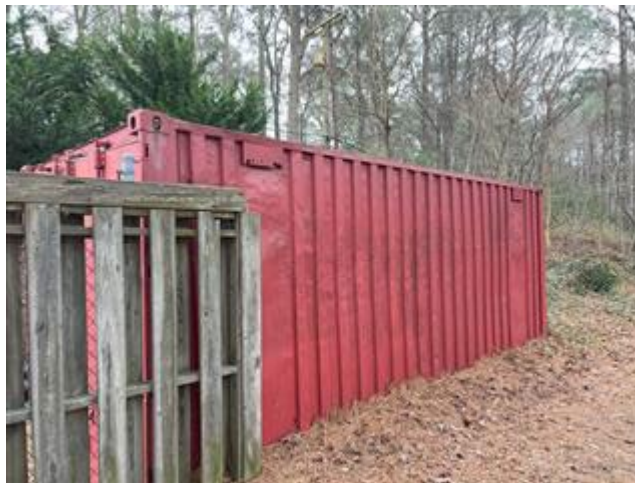
Sheds. The Association owns a wooden shed as well as an old shipping container that are used for storage purposes. The shed is entered into the Reserve Study and appears to be in good condition. NOTE: The shipping container is not listed as an MDA component item in this Reserve Study.

We have assumed that the components of the wooden shed's exterior will be replaced as needed (using other funds), and when a complete replacement is required, it will be replaced with one of a similar type and size.

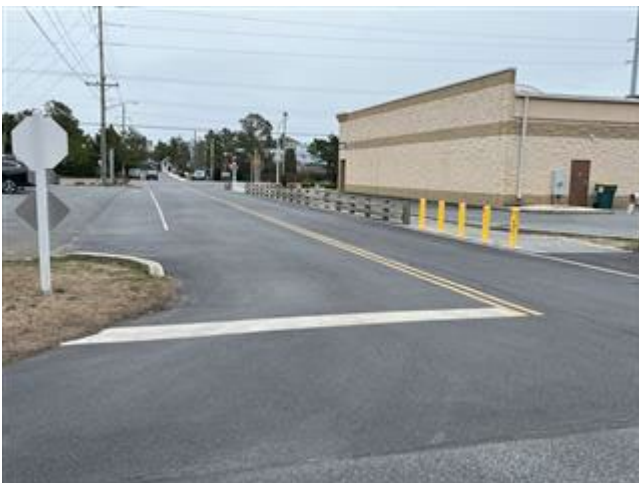
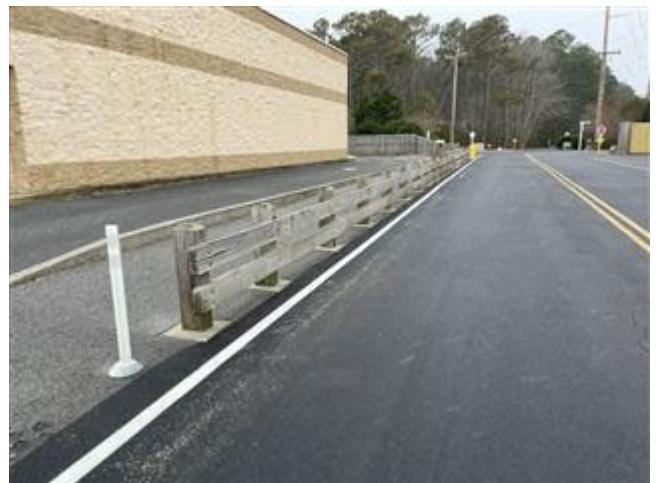
Pedestrian Barrier. The pedestrian barrier is located on Bridge Rd, and the wooden portion was installed in 2013. Five yellow posts were installed in 2021. The barrier and posts appear to be in good condition. We have modeled for both wooden and steel members to be replaced in 23 years.

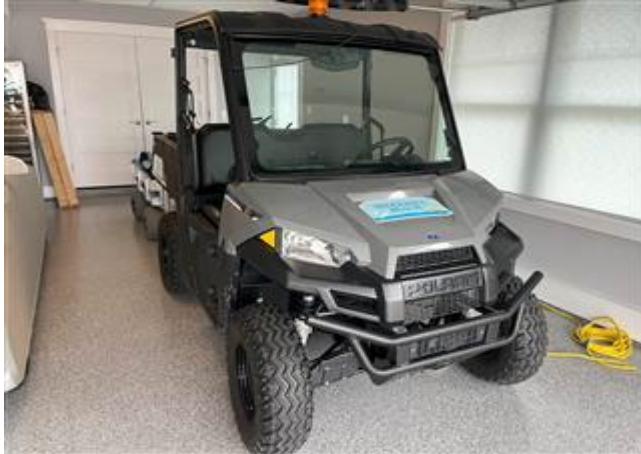
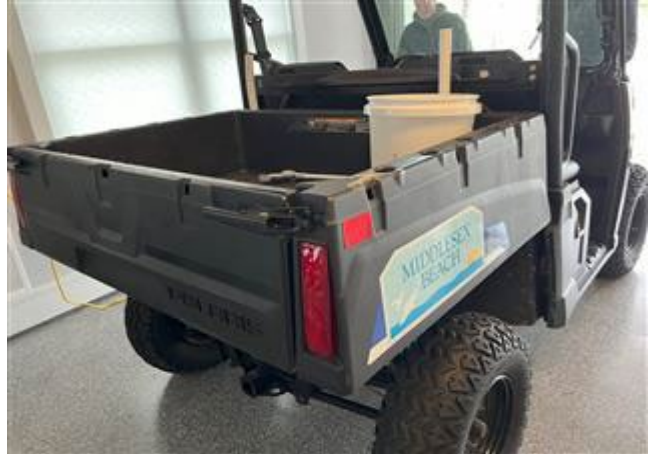
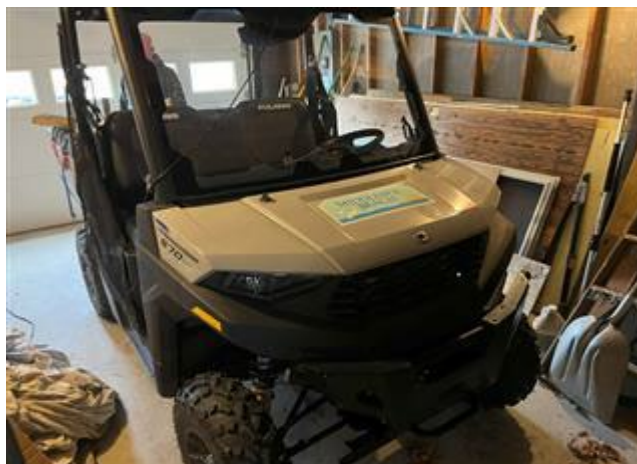
Vehicles. The Association operates three vehicles including an electric Polaris Ranger (2022), a gas Polaris Ranger (2023), and a golf cart (2018). The golf cart could not be accessed but is reportedly in good condition. The Polaris Rangers are both relatively new and appear to be in excellent condition.
